BGJWSC Sanitary Sewer Manhole Inspection Form

SID: 4044 0100
 Northing Coord:
 Easting Coord:
 Address/Intersection: 256 STANTON CORN

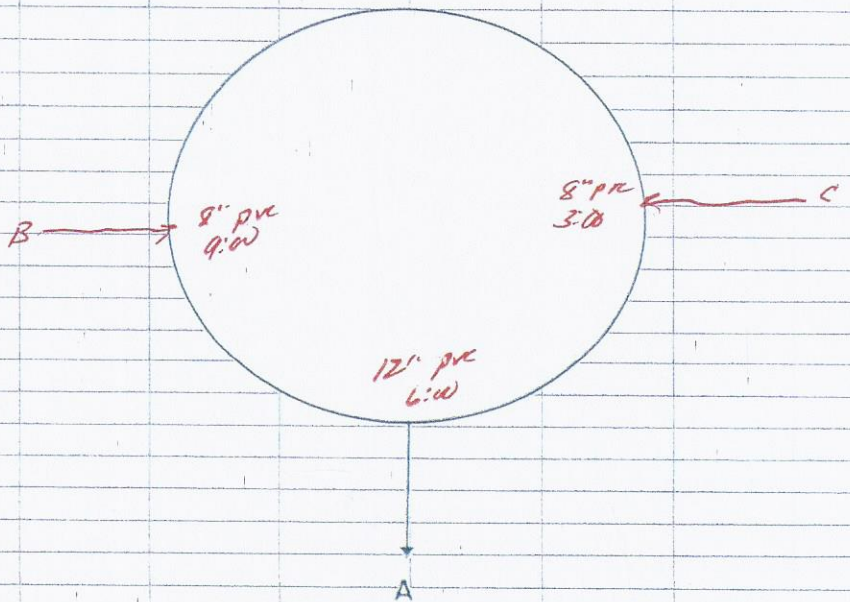
Remarks: Layout All PIPES INSIDE MH
