**Visual Inspection Report**

**Chapman Technical Services, LLC**

Inspection Date: 05/21/18 01:30 PM

## Demere Road Tank

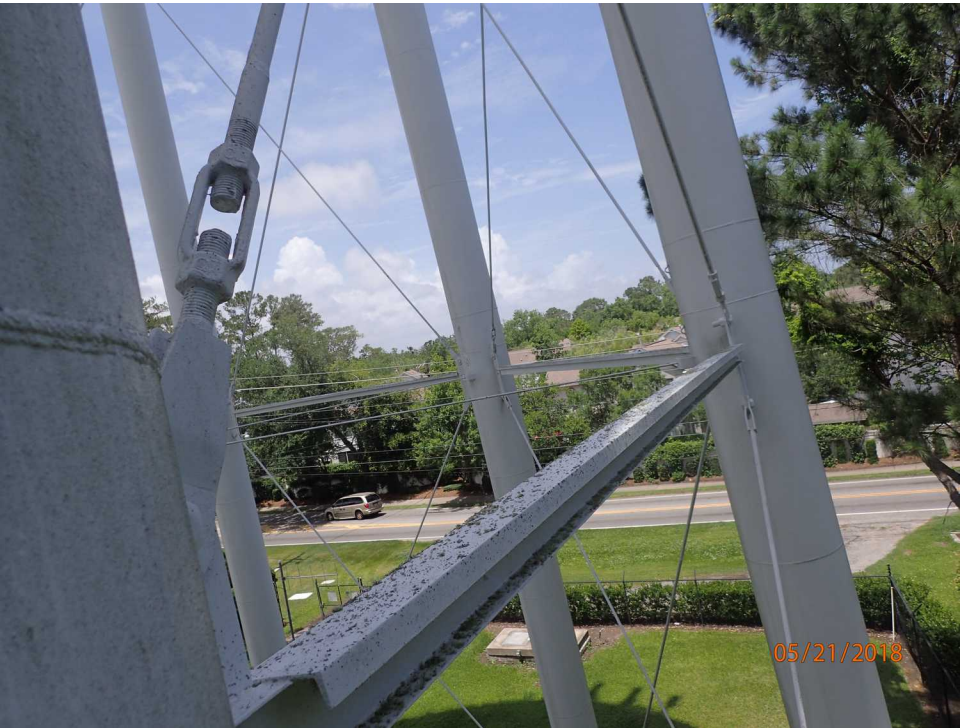
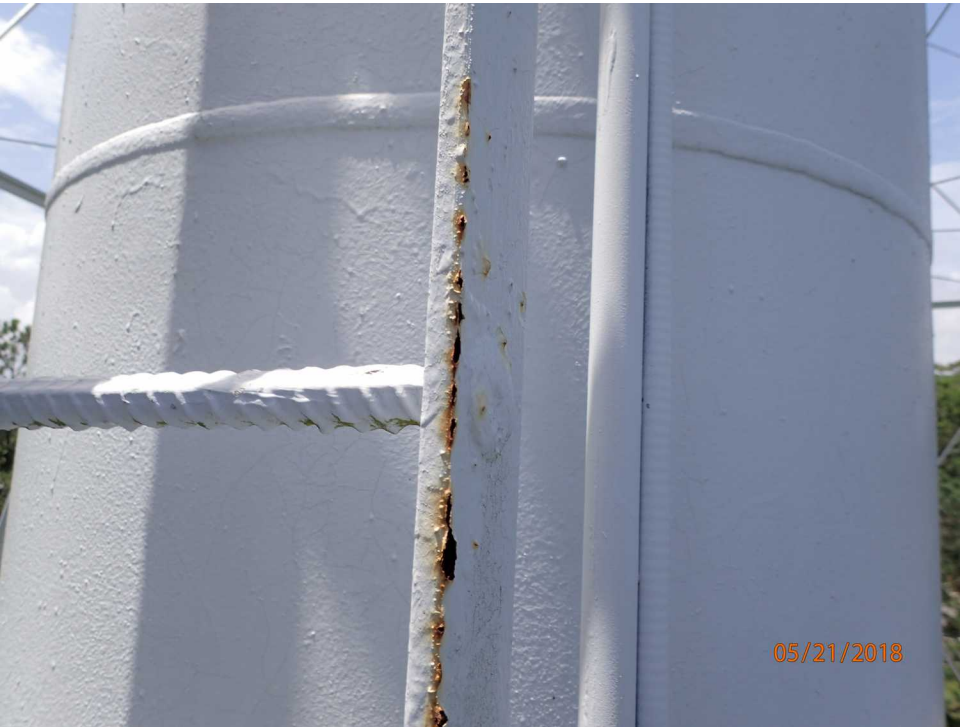
- \* The vent is in good condition
- \* The ladders on the tank and the exterior leg needs to be touched up, There are many spots with rust.
- \* Hatch has rusting spots.

Rust on ladder

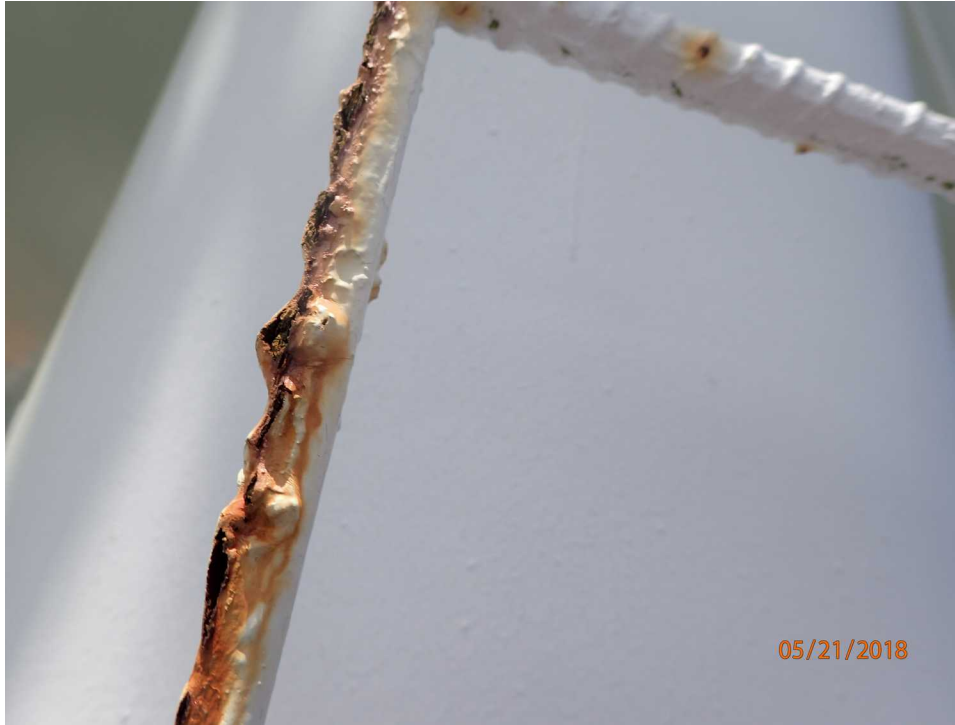
- \* The legs and riser are in good condition .
- \* The rods and braces are rusting badly.

Rods rusting badly

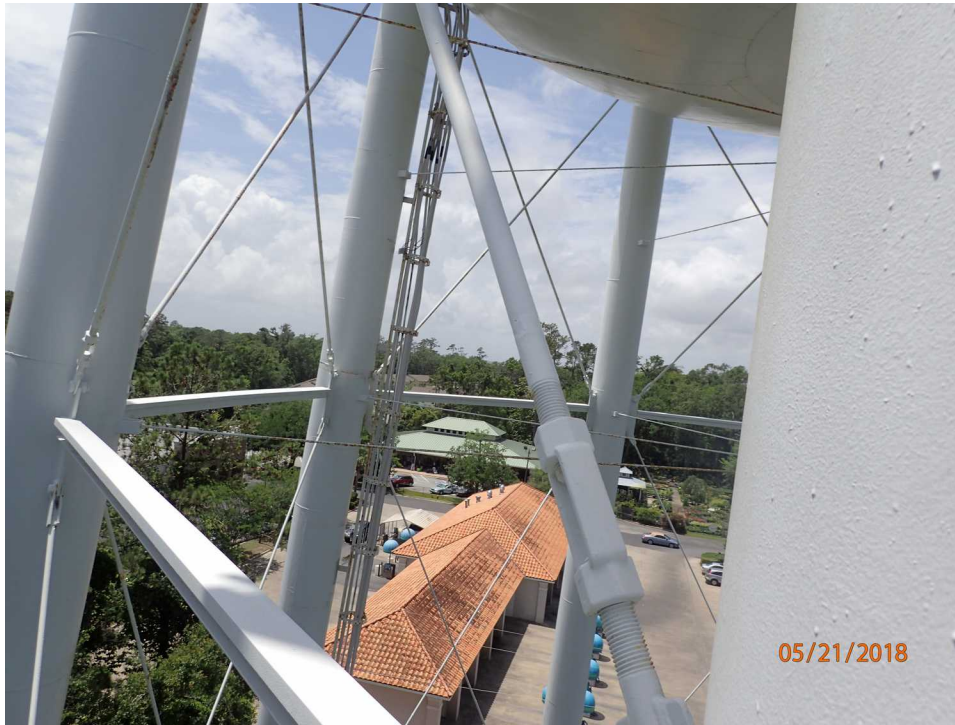
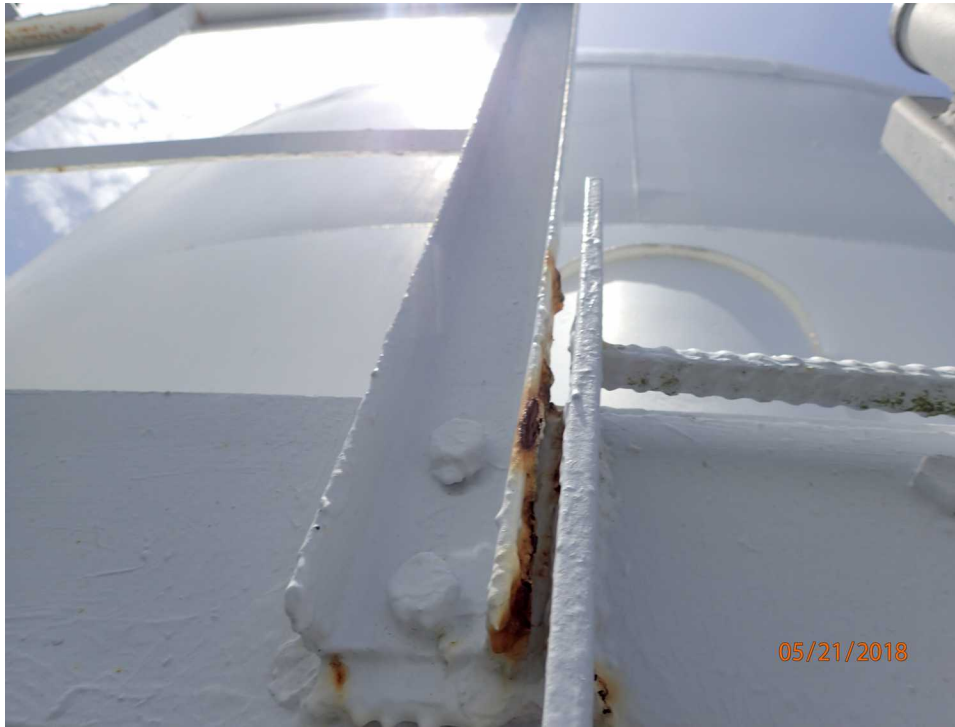
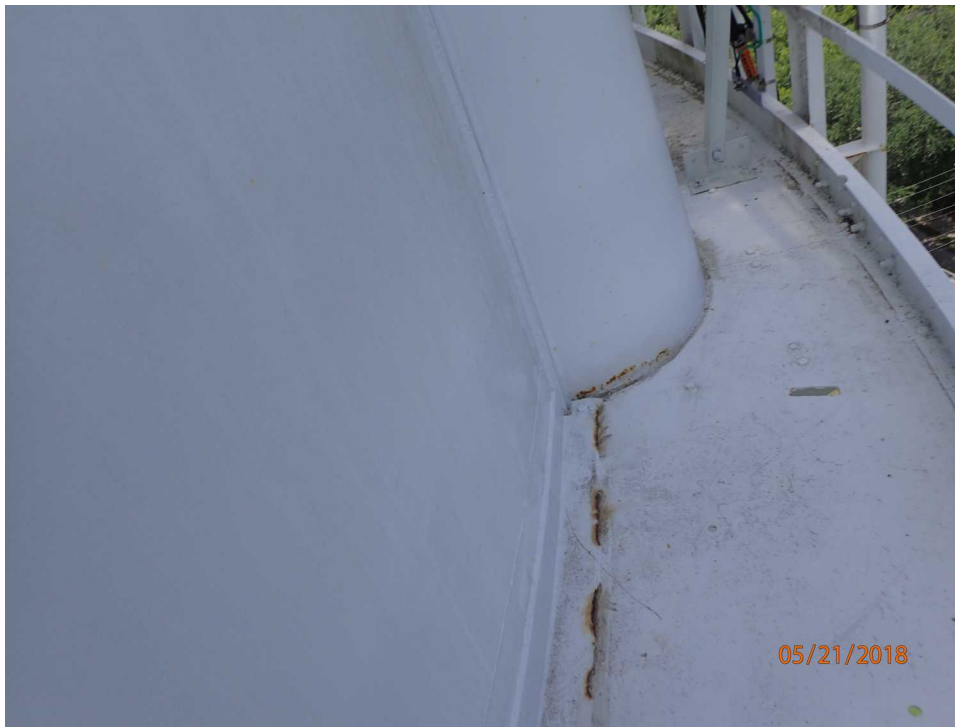
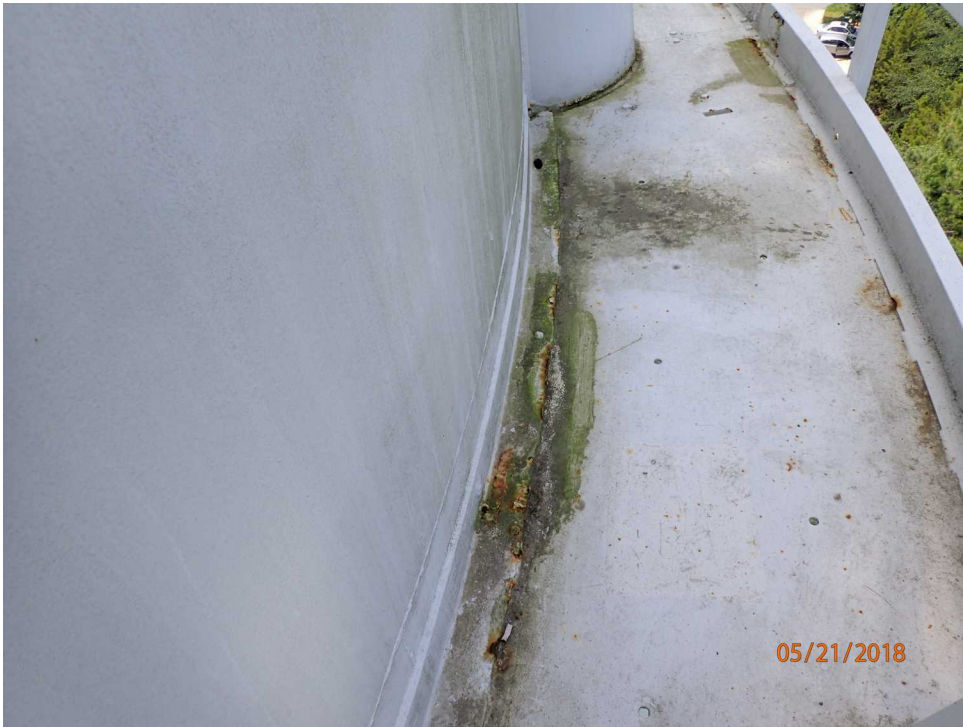
- \* The catwalk has multiple rust spots of concern.

Rust on catwalk

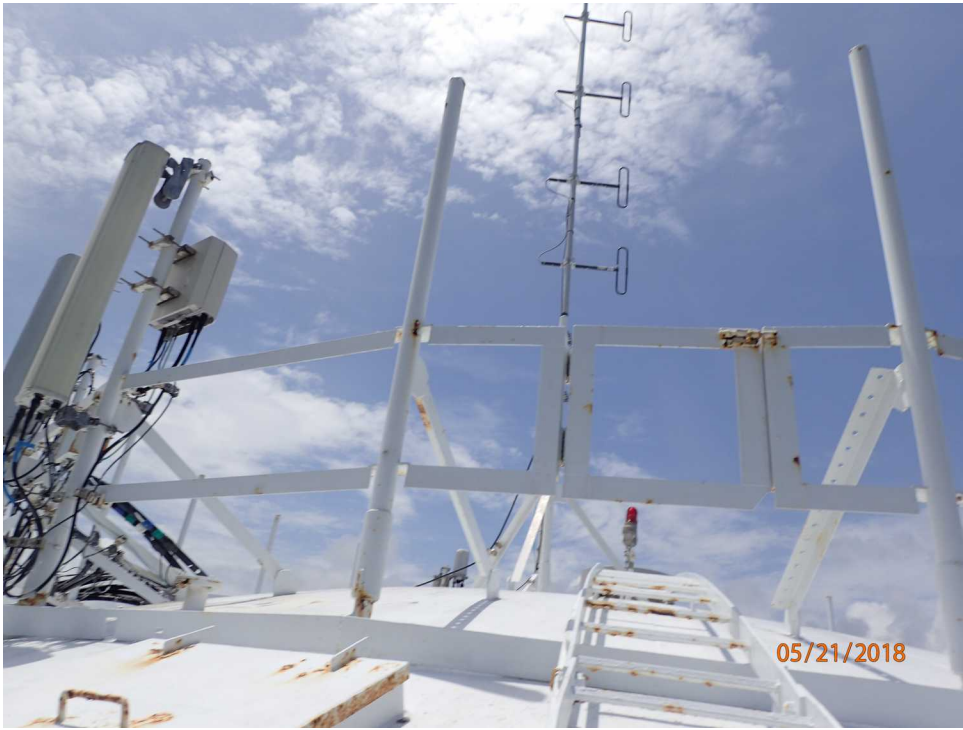
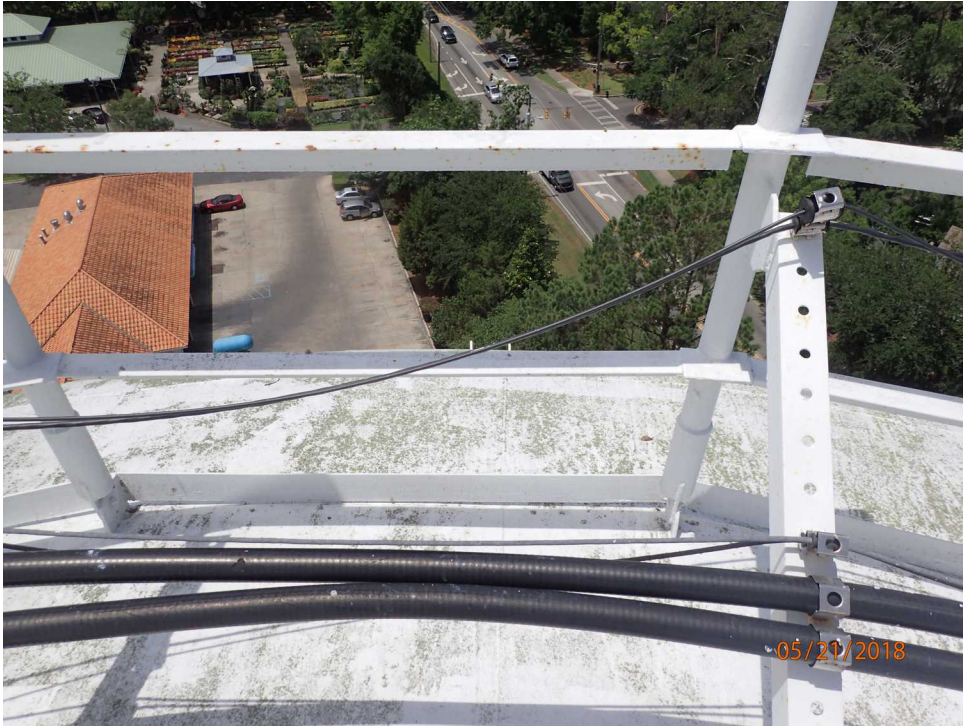
Moss on top of tank

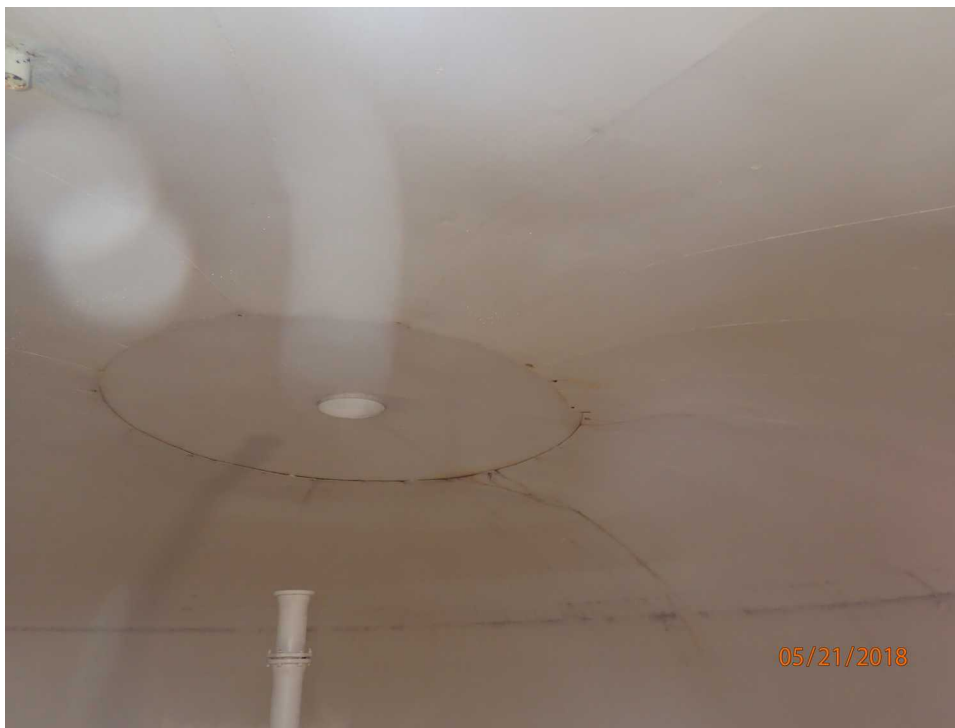
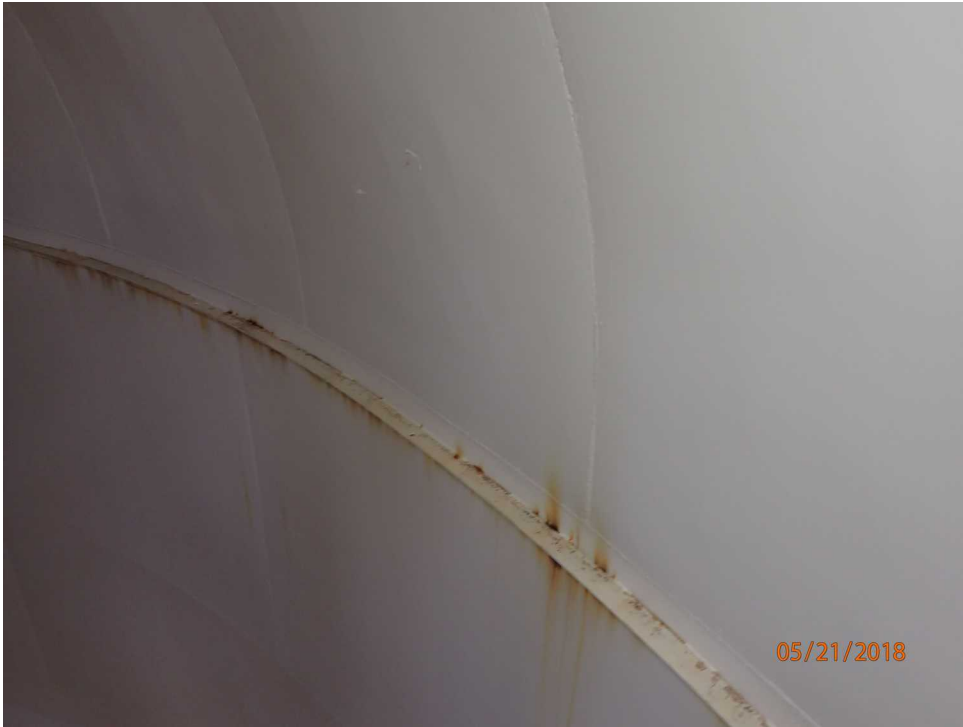
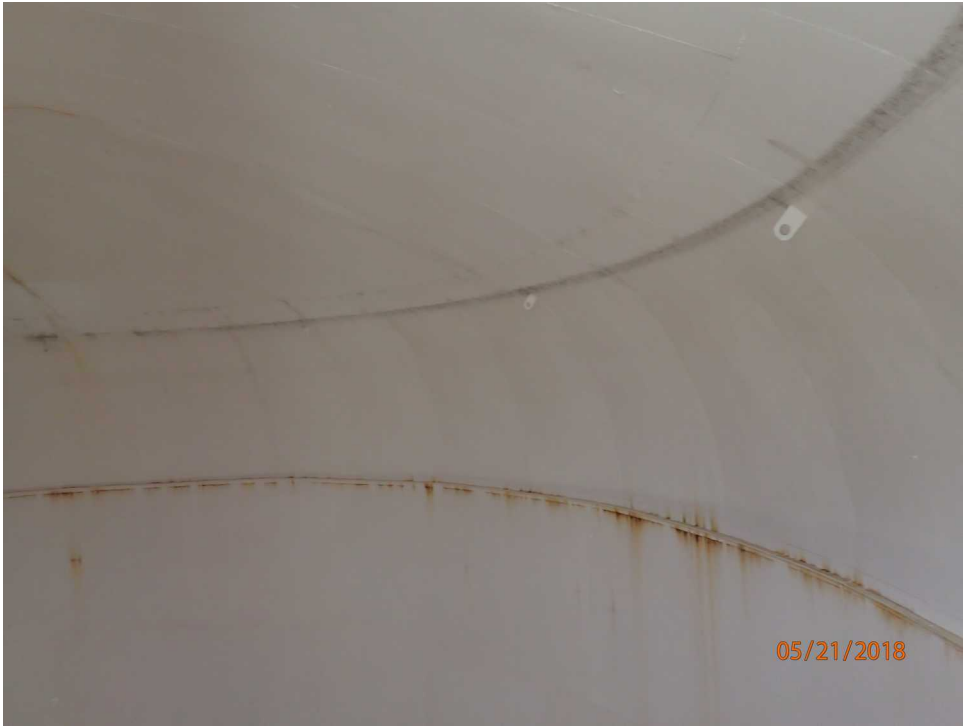
- \* The angle on the side of the tank has multiple locations with rust that need to be touched up.

Rust on interior side angle

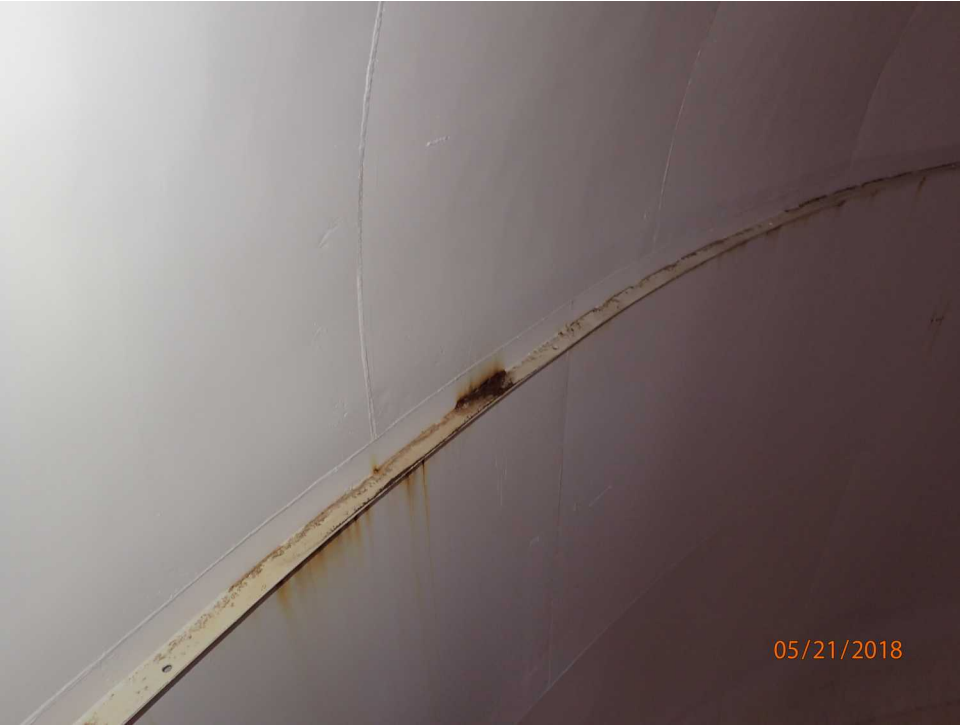
Interior bowl
