Inspection report

Date: 8/15/2012	Work Order:	Weather: Dry	Surveyed By: BSWEAT	Certificate Number: U-807-5076	Pipe Segment Ref.: 20320010+20320000
Year laid:	Pre-cleaning:	Direction: Downstream	Pipe Joint Length:	Total Length: 25.8'	Length Surveyed: 25.0'

City: St Simons	Drainage Area: 2032	Upstream MH: 20320010
Street: 5615 FREDERICA	Media Label: 1	Up Rim to Invert: 0.0
Location Code: Easement/Right of way	Flow Control: Not Controlled	Downstream MH: 20320000
Location Details:	Sheet Number:	Down Rim to Invert: 0.0
Pipe shape: Circular	Sewer Use: Sanitary	Total gallons used: 0.0
Pipe size: 12"	Sewer Category: SEC	Joints passed: 0
Pipe material: Ductile Iron Pipe	Purpose: Infiltration/Inflow Investigation	Joints failed: 0
Lining Method:	Owner: BGJWSC

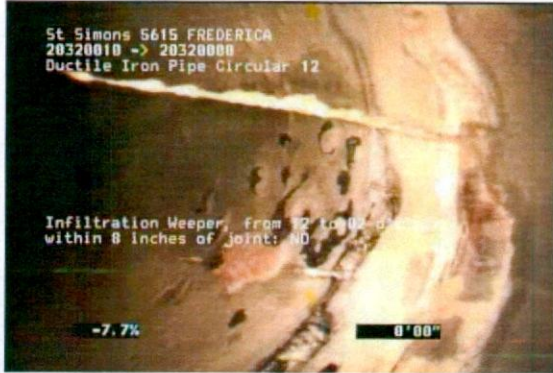
20320010+20320000_9270dadce80e45f39b5e328665ed4
8bf_20181017_083253_465.jpg, 00:00:41, 0.00ft
Infiltration Dripper at 12 o'clock, within 8 inch / At pipe in
manhole

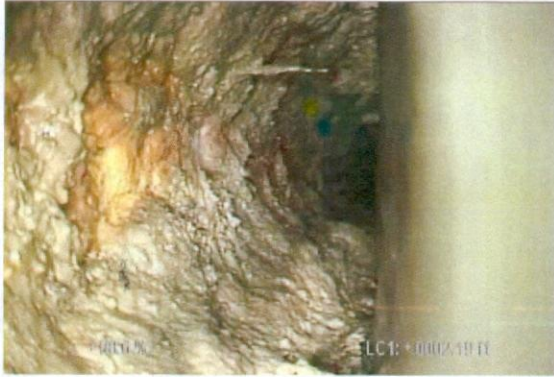
20320110+20320100_24f3b84a-7ff4-456c-ba16-8fb5cb33b64
f.JPG, 00:02:02, 2.10ft
Survey Abandoned / Tuberculated Pipe

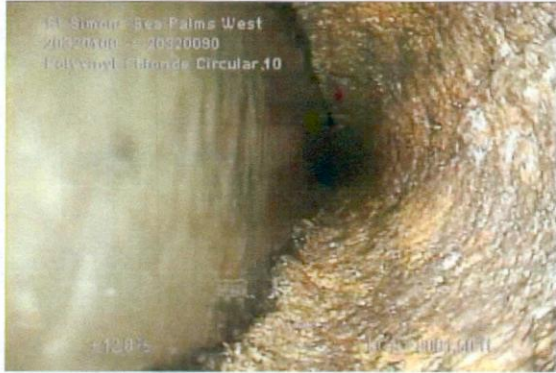
20320100+20320090_01067181-83d9-46b2-a58e-6da71546f
462.JPG, 00:01:00, 2.00ft
Survey Abandoned / Tuberculated Pipe

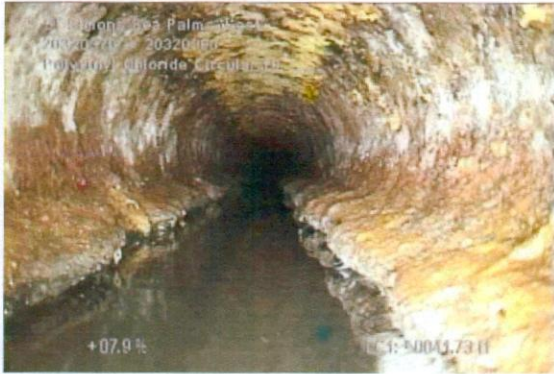
20320370+20320360_812fb25c-ea8a-47a8-8bee-a00060d30c
d6.JPG, 00:02:07, 0.00ft
Survey Abandoned / Tuberculation

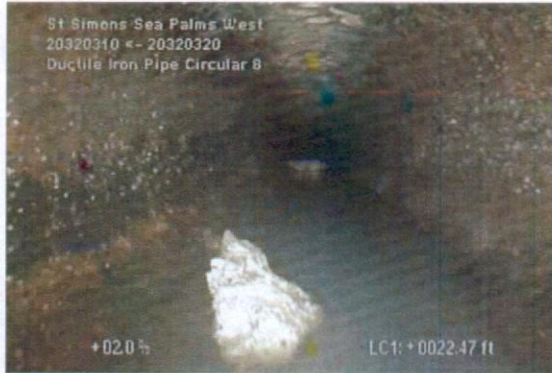
20320320+20320310_e1a50533-6f09-4024-b5b4-33bb82cfc6
b8.jpg, 00:02:36, 37.80ft
Water Level, 35% of the vertical dimension

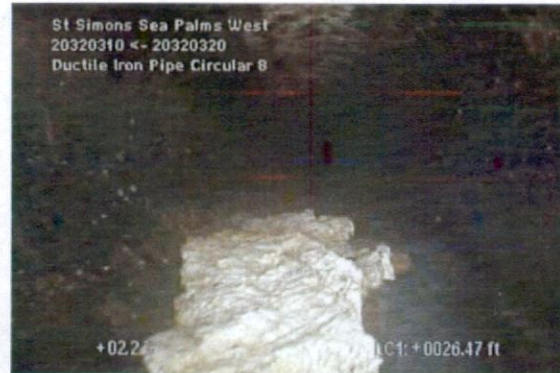
20320320+20320310_e7d28b0f-29de-4885-91a1-d8e920db3
0e1.jpg, 00:02:36, 37.80ft
Water Level, 35% of the vertical dimension

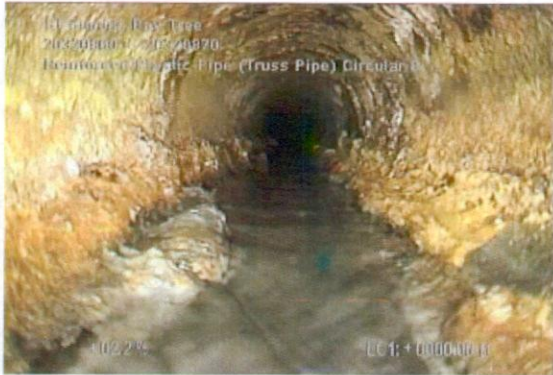
20320870+20320760_015dad57-27fd-4ef1-bfe7-43534bf8e4f
2.JPG, 00:00:43, 0.00ft
Survey Abandoned / Tuberculation

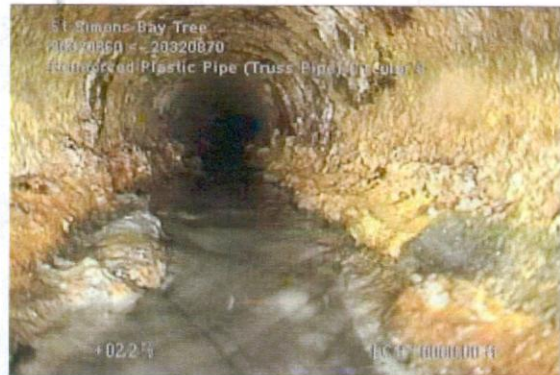
20320870+20320760_75b1b7e8-df9c-44b0-953f-834956f113
0e.JPG, 00:00:43, 0.00ft
Survey Abandoned / Tuberculation

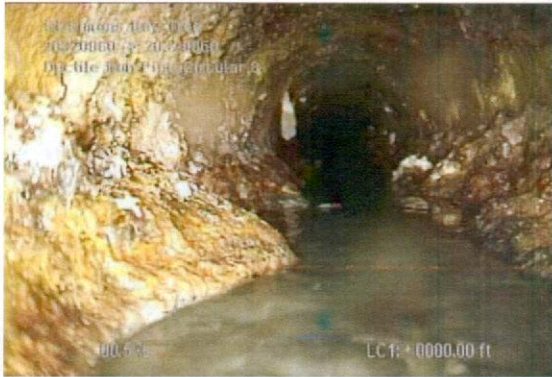
20320860+20320850_fa4fa195-62c2-4776-b60f-856e32cb14b
c.JPG, 00:01:20, 0.01ft
Survey Abandoned / Tuberculation

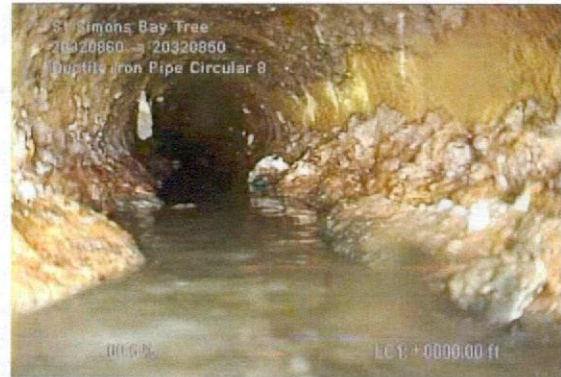
20320860+20320850_3ed72094-20d7-4c00-b5d2-86549a812
38b.JPG, 00:01:20, 0.01ft
Survey Abandoned / Tuberculation
