#2106 DUNBAR CREEK WPCF REHAB (IN PROGRESS - TBD)

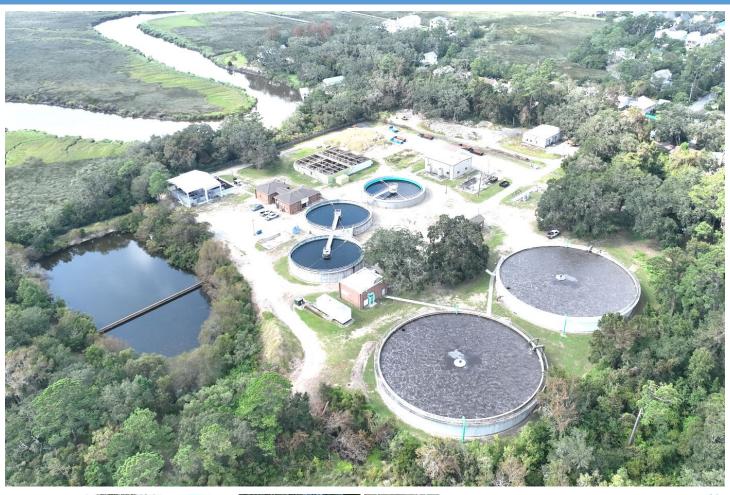
- 1. Post-Hurricane Helene Inspection: A large oak tree fell at the back entrance, and staff used heavy equipment to remove it. And Post Hurricane Milton inspection no site issues or damage to report.
- 2. View of the large oak tree that fell at the back entrance removed from blocking service access to the plant.
- 3. View of the newly installed Scum Pump Station next to the new clarifier splitter box in the background.
