## Inspection photos

| City :<br>Brunswick | Street :<br>111 F Street | Date :<br>4/30/2018 | Pipe Segment Reference :<br>40320280+40320270 | Section No :<br>1 |

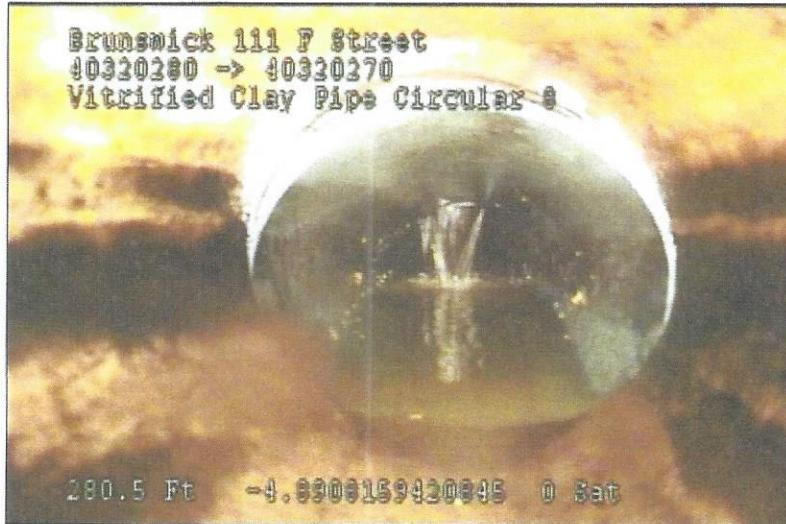
Photo: 40320280\_40320270\_02052018\_134435\_A.jpg, VCR No.: 1  
281.9FT, Joint Offset Medium

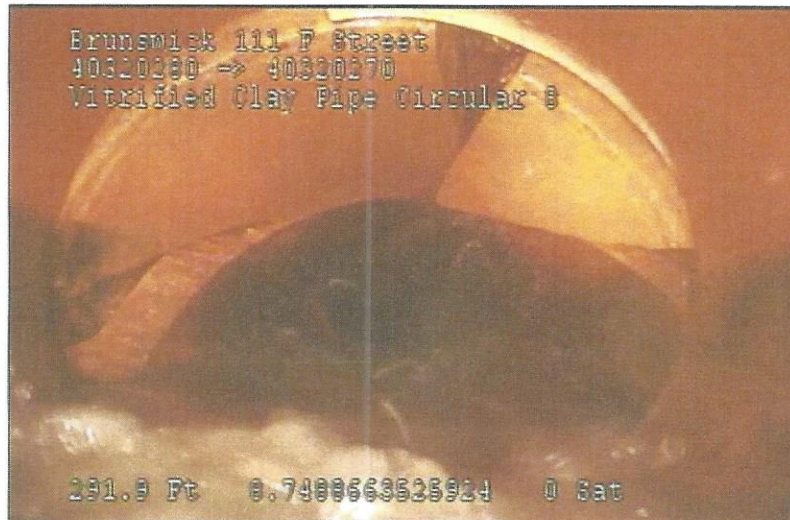
Photo: 40320280\_40320270\_30042018\_104417\_A.JPG, VCR No.: 1  
292.2FT, Broken Soil Visible, from 08 to 08 o'clock, within 8 inches of joint: YES
