Facility Construction Project Photos – January 2023

2203 EST REHAB AT GLYNN PLACE MALL AND OGLETHORPE SITES (3% - JUNE 2023)

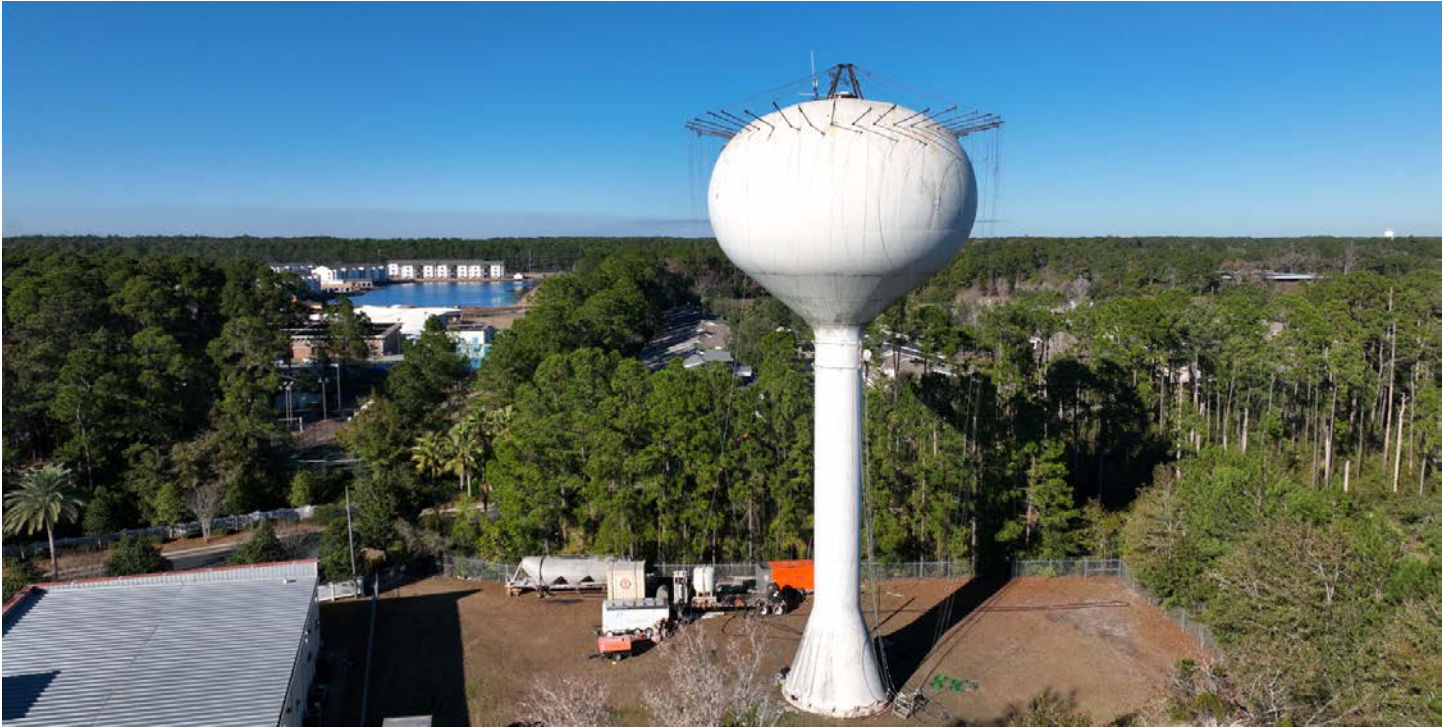
1. Drone view of the Glynn Mall Place EST – The Contractor is preparing the outrigger containment system to erect a tent-like curtain structure to contain sandblast media, paint overspray, and other debris associated with sandblasting and painting during the rehabilitation process.
2. Interior view of the existing piping and valve assemblies inside the pedestal base in the Oglethorpe EST.
