Facility Construction Project Photos – July 2022

2106 DUNBAR CREEK WPCF REHAB (IN PROGRESS-TBD)

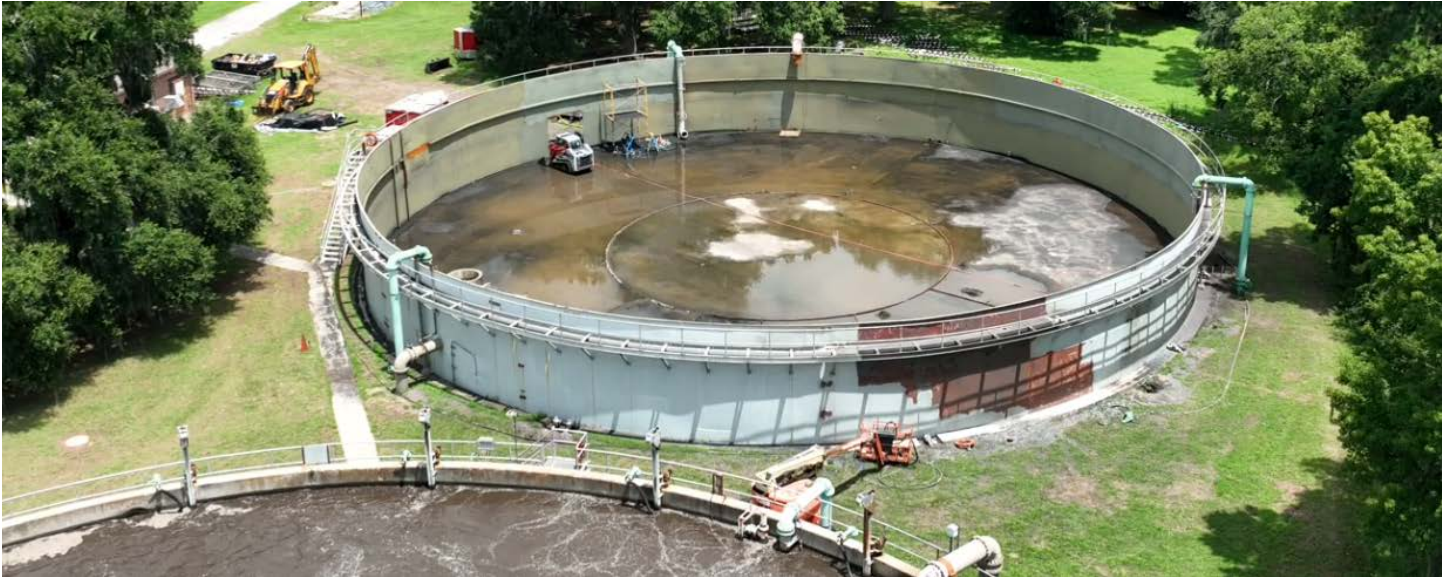
1. North drone overview of the ongoing construction activities at the Dunbar Aeration Basin #2.
2. Ongoing blasting on all exposed walkways and exterior walls.
3. Weld plates are added to sections where corrosion has reduced effective wall thickness.
4. Existing air piping to be blasted and coated.
5. Existing influent piping to be blasted and coated.
