Facility Construction Project Photos – September 2022

2106 DUNBAR CREEK WPCF REHAB (IN PROGRESS-TBD)

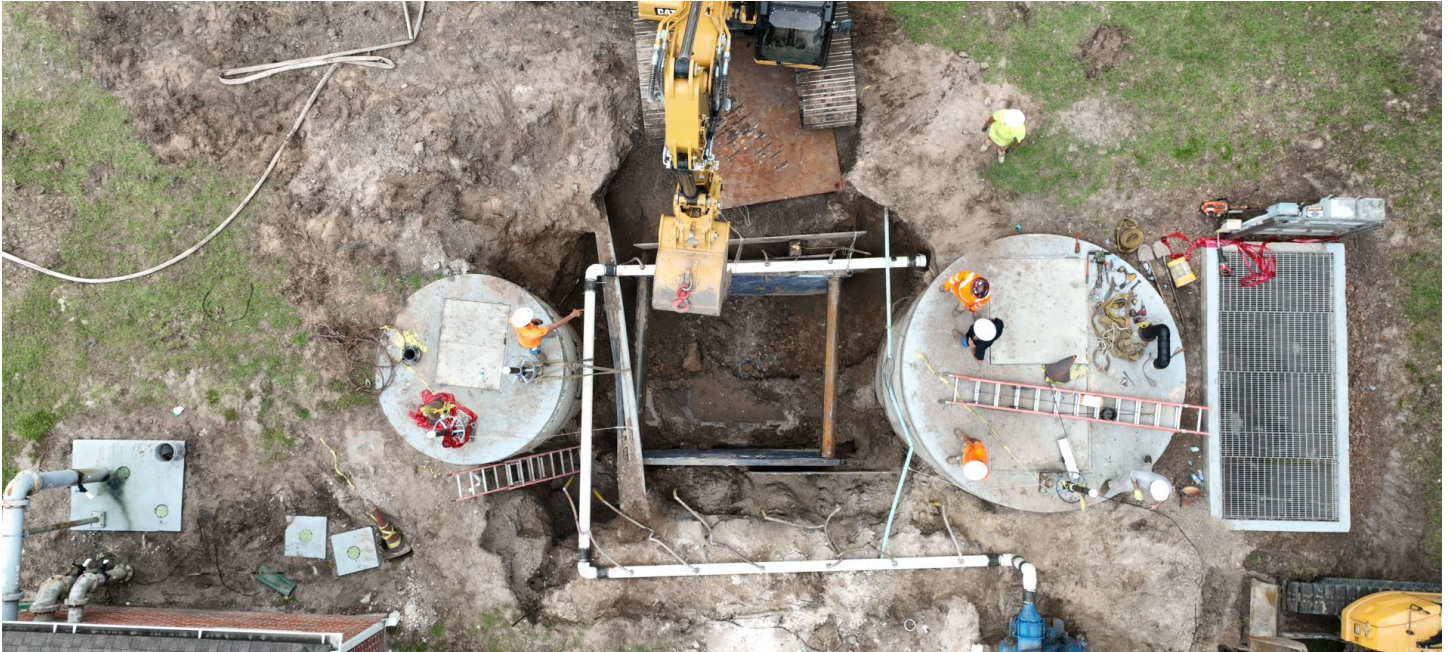
1. Drone overhead view of ongoing construction activities between Wet Wells #2WTP1630 and #2WTP1730 – BRW Construction Group, LLC (Contractor) addressing 30-inch pipe collapse.
2. View of 30-inch deteriorated DIP sewer line removed between Wet Wells #2WTP1630 and #2WTP1730 – the final site restoration of pipe collapse pending delivery of roadway material.
