Facility Construction Project Photos – March 2023

2106 DUNBAR CREEK WPCF REHAB (IN PROGRESS-TBD)

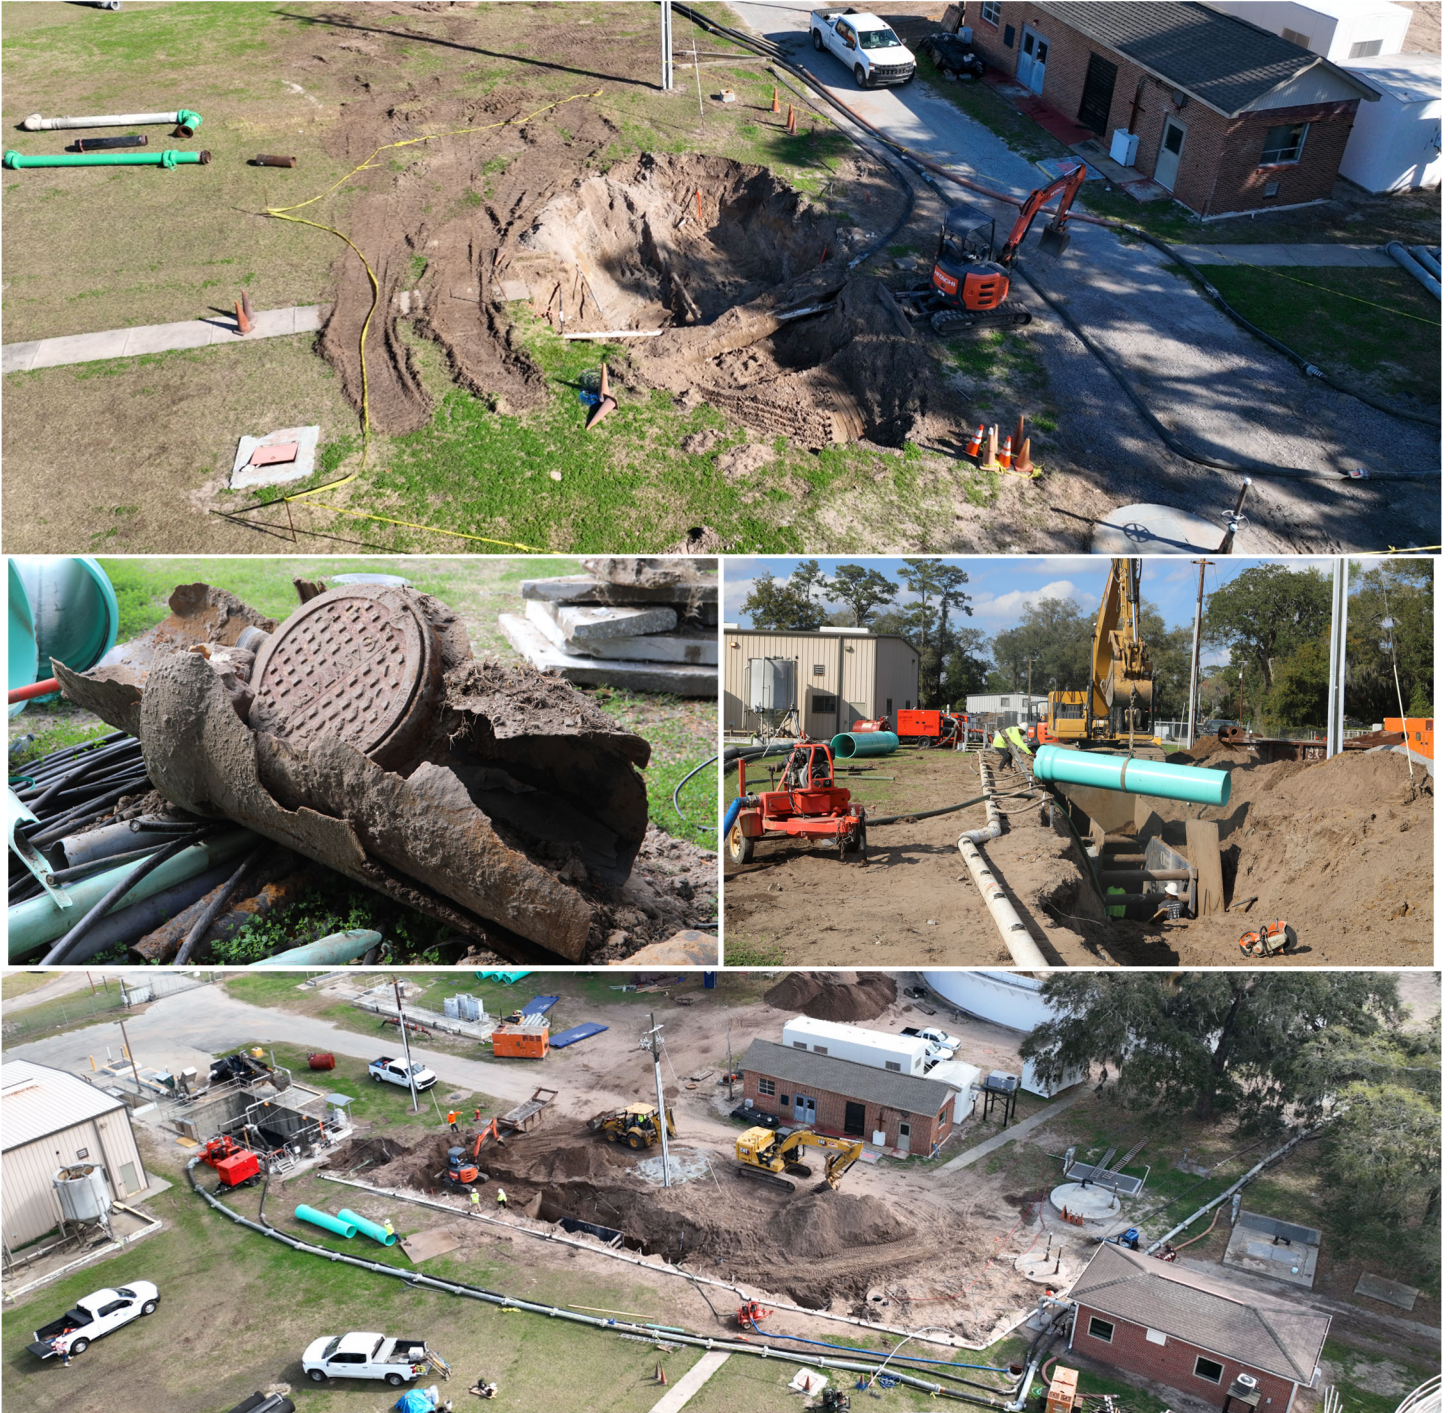
1. Drone view of the contractor mobilizing additional bypass equipment to address sinkhole forming due to a failed 30-inch DIP sewer pipe connecting the grit chamber to a wetwell near the RAS bldg.
2. View of failed 30-inch DIP sewer pipe section removed.
3. The contractor is removing the existing sewer pipe, replacing it with new 30-inch PVC piping, and installing new manhole access points along the alignment.
4. Drone view of the ongoing 30-inch sewer replacement activities.
