## Facility Construction Project Photos – October 2023

#2215B HWY 341 CRISPEN (IN PROGRESS-TBD)

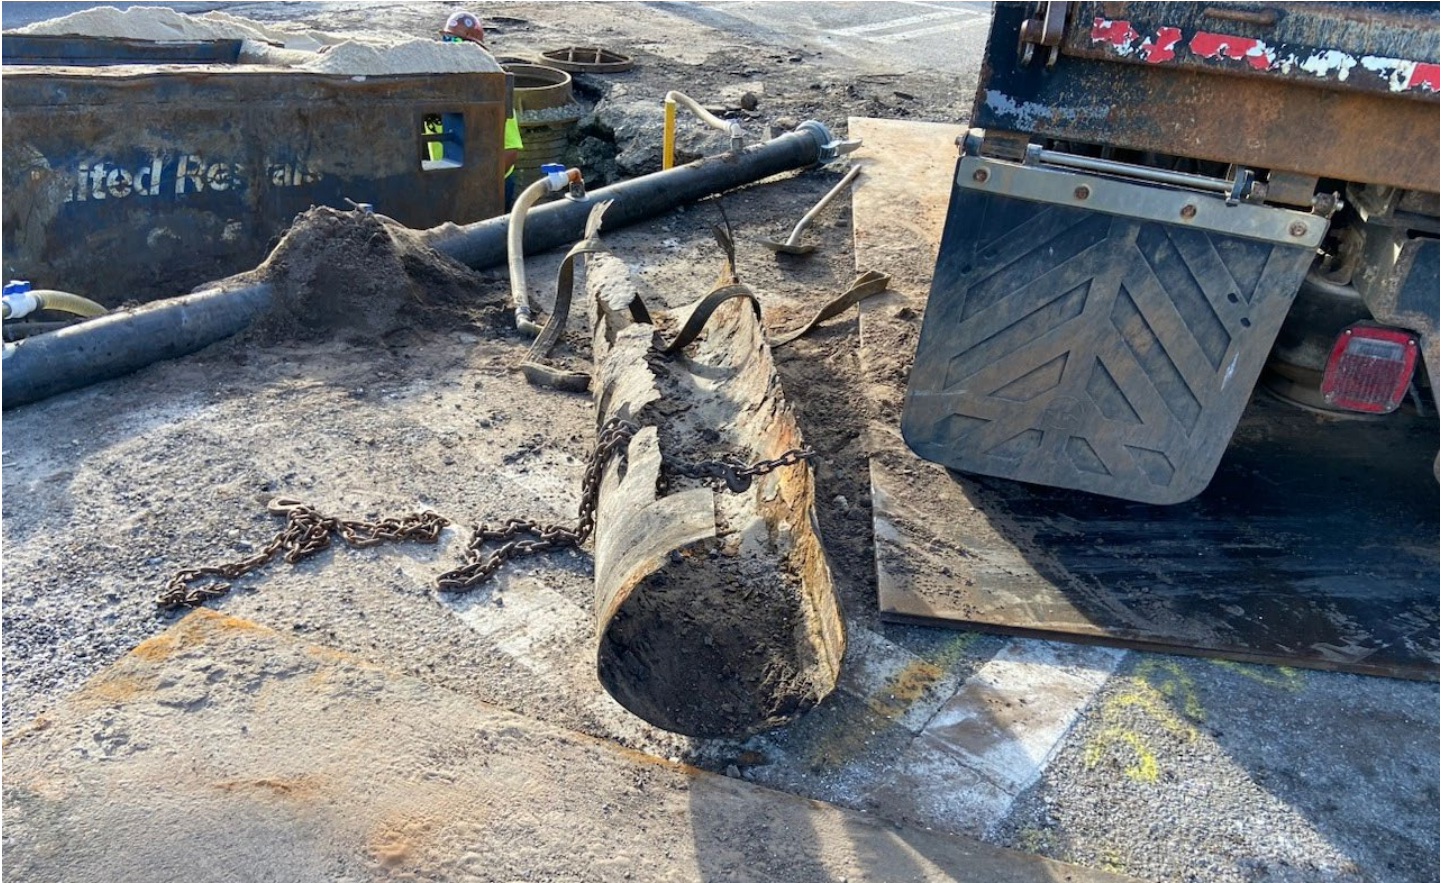
1. A failed 18-inch sewer pipe was removed from the project site.
2. A westbound view of the 3-inch steel trench box was placed to ensure the shoring requirements were met during construction activities.
3. View from the inside of the trench box – the Contractor has replaced approximately 8 feet of the failed sewer pipe, and cure-in-place pipe lining material is pending final delivery from the manufacturer. An existing 24-inch storm pipe was removed and replaced with a temporary 18-inch pipe to allow the trench box to be installed without further excavating into additional travel lanes.
