Inspection report

Date: 8/15/2012	Work Order:	Weather: Dry	Surveyed By: BSWEAT	Certificate Number: U-807-5076	Pipe Segment Ref.: 20320010+20320000
Year laid:	Pre-cleaning:	Direction: Downstream	Pipe Joint Length:	Total Length: 25.8'	Length Surveyed: 25.0'

City: St Simons	Drainage Area: 2032	Upstream MH: 20320010
Street: 5615 FREDERICA	Media Label: 1	Up Rim to Invert: 0.0
Location Code: Easement/Right of way	Flow Control: Not Controlled	Downstream MH: 20320000
Location Details:	Sheet Number:	Down Rim to Invert: 0.0
Pipe shape: Circular	Sewer Use: Sanitary	Total gallons used: 0.0
Pipe size: 12"	Sewer Category: SEC	Joints passed: 0
Pipe material: Ductile Iron Pipe	Purpose: Infiltration/Inflow Investigation	Joints failed: 0
Lining Method:	Owner: BGJWSC

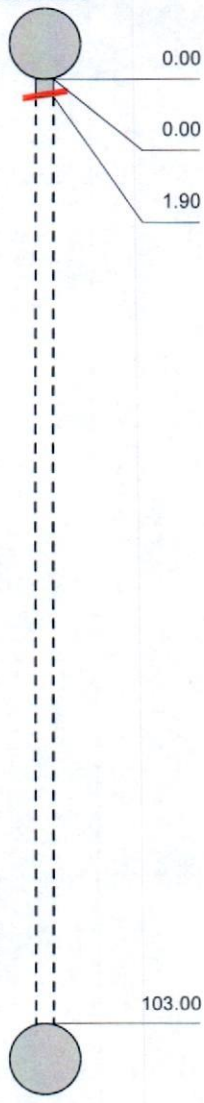
0.00	AMH	Upstream Manhole, Survey Begins / 20320090	00:00:02		
	0.00	MWL	Water Level, 55% of the vertical dimension	00:00:13		
	1.90	MSA	Survey Abandoned / Tuberculated Pipe Stops Camera	00:03:40		
	103.00		End of pipe			
QSR	QMR	SPR	MPR	OPR	SPRI	MPRI
0000	0000	0.0	0.0	0.0	0.0	0.0

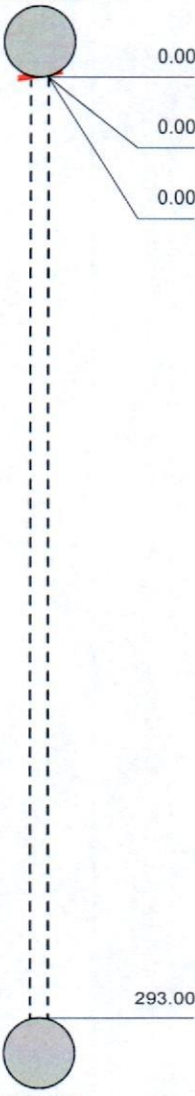
0.00	AMH	Upstream Manhole, Survey Begins / 20320370	00:00:03		
	0.00	MWL	Water Level, 30% of the vertical dimension	00:00:19		
	0.00	MSA	Survey Abandoned / Tuberculation	00:02:07	20320370 _2032036 0_120220	
	293.00		End of pipe			
20320360						
QSR	QMR	SPR	MPR	OPR	SPRI	MPRI
0000	0000	0.0	0.0	0.0	0.0	0.0

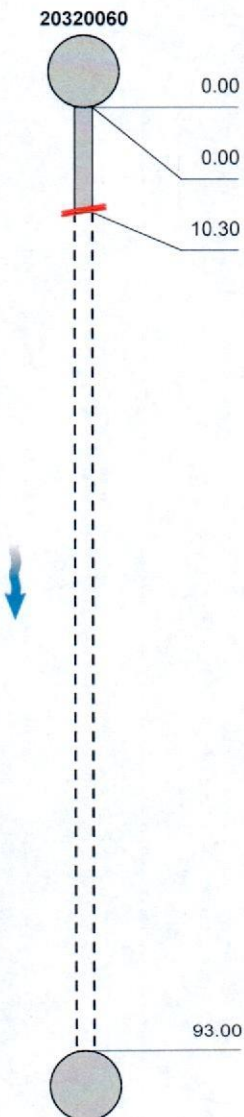
0.00	AMH	Upstream Manhole, Survey Begins / 20320060	00:00:02		
	0.00	MWL	Water Level, 60% of the vertical dimension	00:00:07		
	10.30	MSA	Survey Abandoned / Tuberculated Pipe Stops Camera	00:01:35		
	93.00		End of pipe			
QSR	QMR	SPR	MPR	OPR	SPRI	MPRI
0000	0000	0.0	0.0	0.0	0.0	0.0

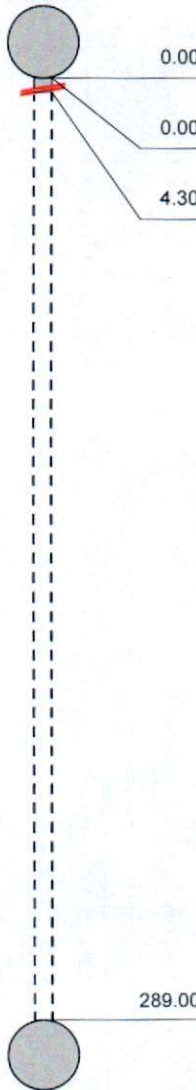
0.00	AMH	Upstream Manhole, Survey Begins / 20320880	00:00:02		
	0.00	MWL	Water Level, 30% of the vertical dimension	00:00:12		
	4.30	MSA	Survey Abandoned / Tuberculated Pipe Stops Camera	00:01:27		
	289.00		End of pipe			
QSR	QMR	SPR	MPR	OPR	SPRI	MPRI
0000	0000	0.0	0.0	0.0	0.0	0.0

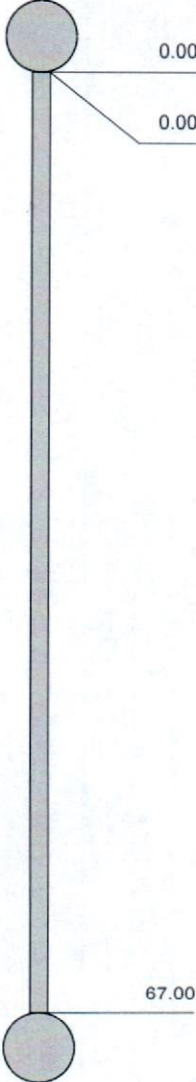
0.00	AMH	Downstream Manhole, Survey Begins / 20320680	00:00:03		
	0.00	MWL	Water Level, 5% of the vertical dimension	00:00:14		
	67.00	AMH	Upstream Manhole, Survey Ends / 20320690	00:02:52		
20320690						
QSR	QMR	SPR	MPR	OPR	SPRI	MPRI
0000	0000	0.0	0.0	0.0	0.0	0.0

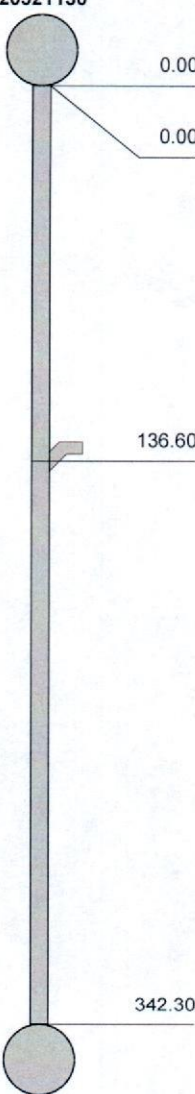
0.00	AMH	Upstream Manhole, Survey Begins / 20321130	00:00:05		
	0.00	MWL	Water Level, 15% of the vertical dimension	00:00:24		
	136.60	TF	Tap Factory Made, at 09 o'clock, 6", within 8 inches of joint: YES	00:04:57		
	342.30	AMH	Downstream Manhole, Survey Ends / 20321120	00:18:57		
20321120						
QSR	QMR	SPR	MPR	OPR	SPRI	MPRI
0000	0000	0.0	0.0	0.0	0.0	0.0

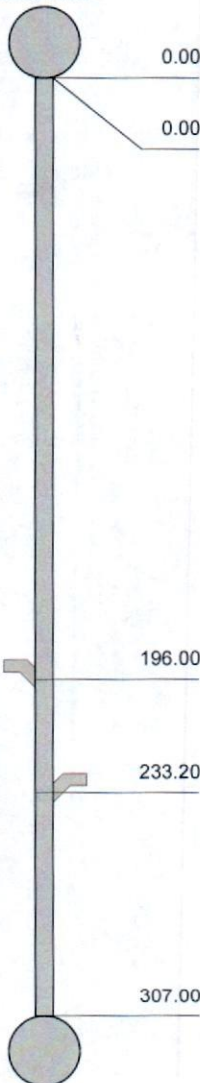
</div><div><div>0.00</div><div>0.00</div><div>196.00</div><div>233.20</div><div>307.00</div></div><div><div>20321170</div></div></div><table><tr><td>QSR</td><td>QMR</td><td>SPR</td><td>MPR</td><td>OPR</td><td>SPRI</td><td>MPRI</td><td>OPRI</td></tr><tr><td>0000</td><td>0000</td><td>0.0</td><td>0.0</td><td>0.0</td><td>0.0</td><td>0.0</td><td>0.0</td></tr></table></div>							QSR	QMR	SPR	MPR	OPR	SPRI	MPRI	OPRI	0000	0000	0.0	0.0	0.0	0.0	0.0	0.0
QSR	QMR	SPR	MPR	OPR	SPRI	MPRI	OPRI															
0000	0000	0.0	0.0	0.0	0.0	0.0	0.0															
AMH	Upstream Manhole, Survey Begins / 20321180	00:00:03																				
MWL	Water Level, 10% of the vertical dimension	00:00:12																				
TF	Tap Factory Made, at 03 o'clock, 6", within 8 inches of joint: YES	00:05:26																				
TF	Tap Factory Made, at 09 o'clock, 6", within 8 inches of joint: YES	00:06:47																				
AMH	Downstream Manhole, Survey Ends / 20321170	00:09:12
