Facility Construction Project Photos – April 2023

#2014 PS 2002 FORCEMAIN REPLACEMENT (SELF-PERFORMED) (IN PROGRESS)

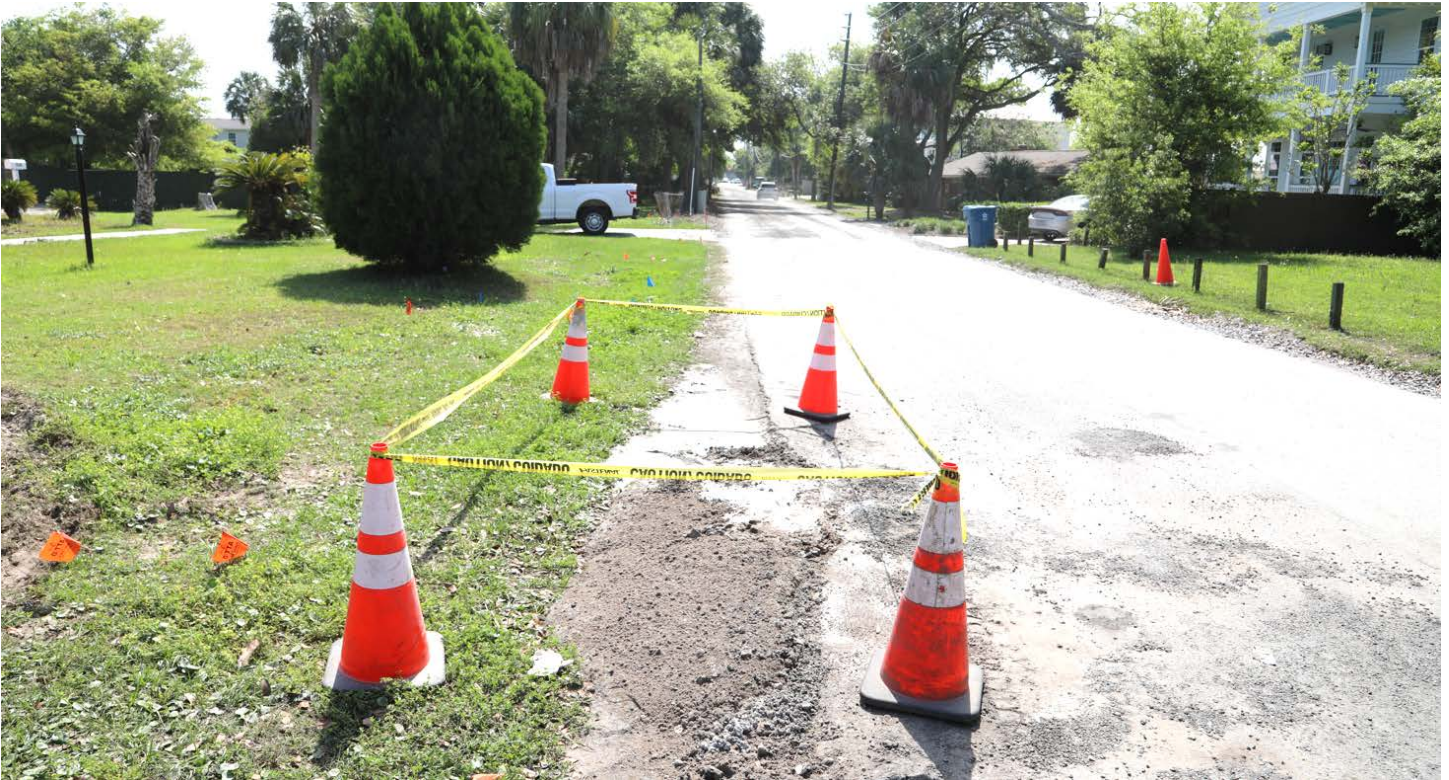
1. Eastbound view of Arnold Road – Approximately 19.5 cubic yards of flowable fill was placed to abandon the existing 10-inch forcemain from the intersection of Demere/Arnold to PS2002.
2. Westbound view of Arnold Road – final roadway replacement to being week of April 17th.
