Facility Construction Project Photos – March 2025

#2406 BASIN 4002 CIPP (IN PROGRESS - TBD)

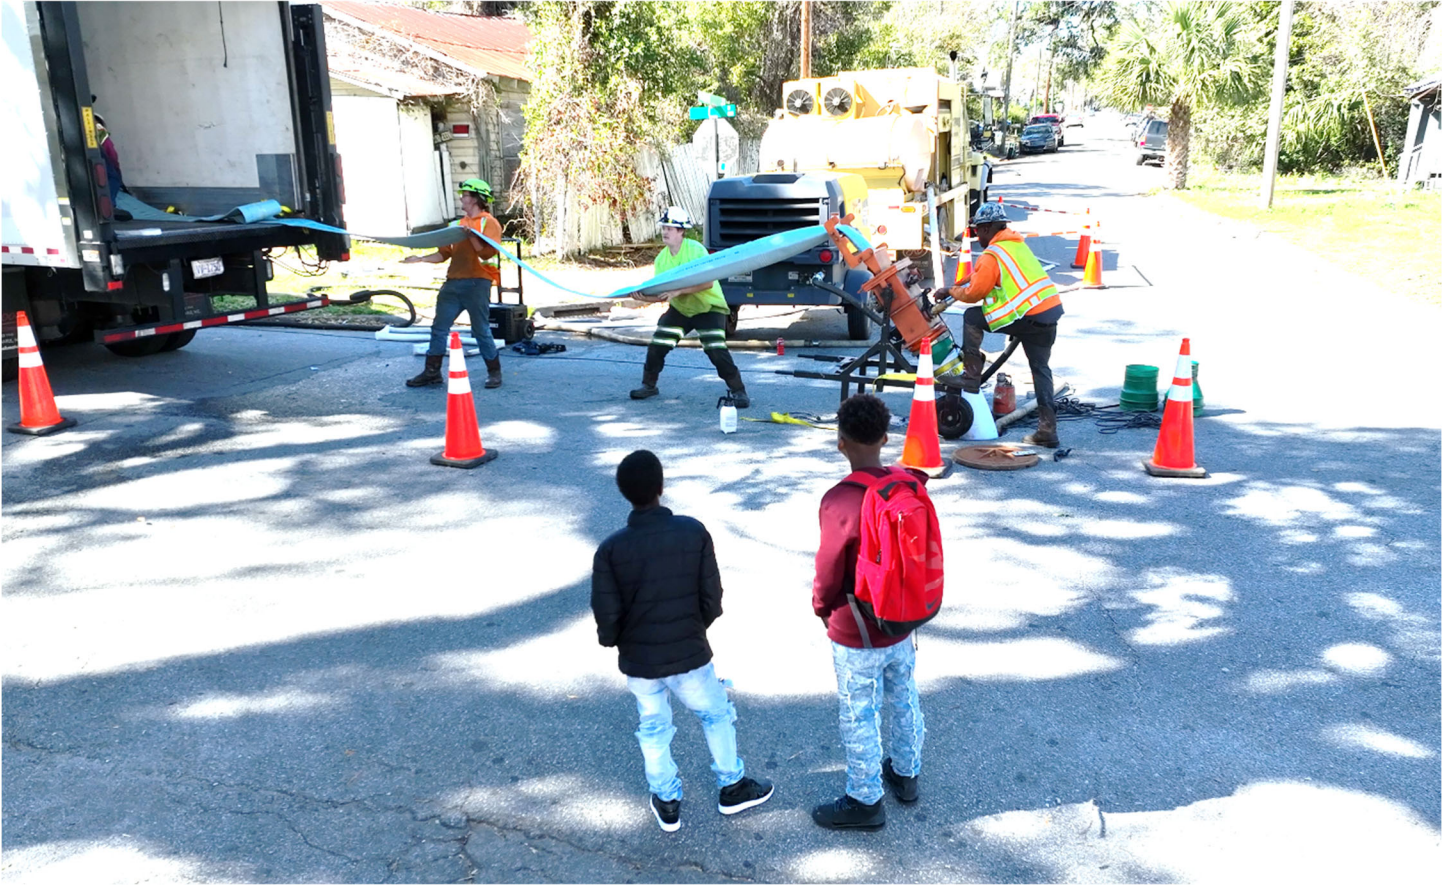
1. Drone view of the City of Brunswick residents observing a 10-inch CIPP liner installation at the I and Wolfe Street intersection. The boys were amazed at the process and said they wanted to work in construction when they grew up.

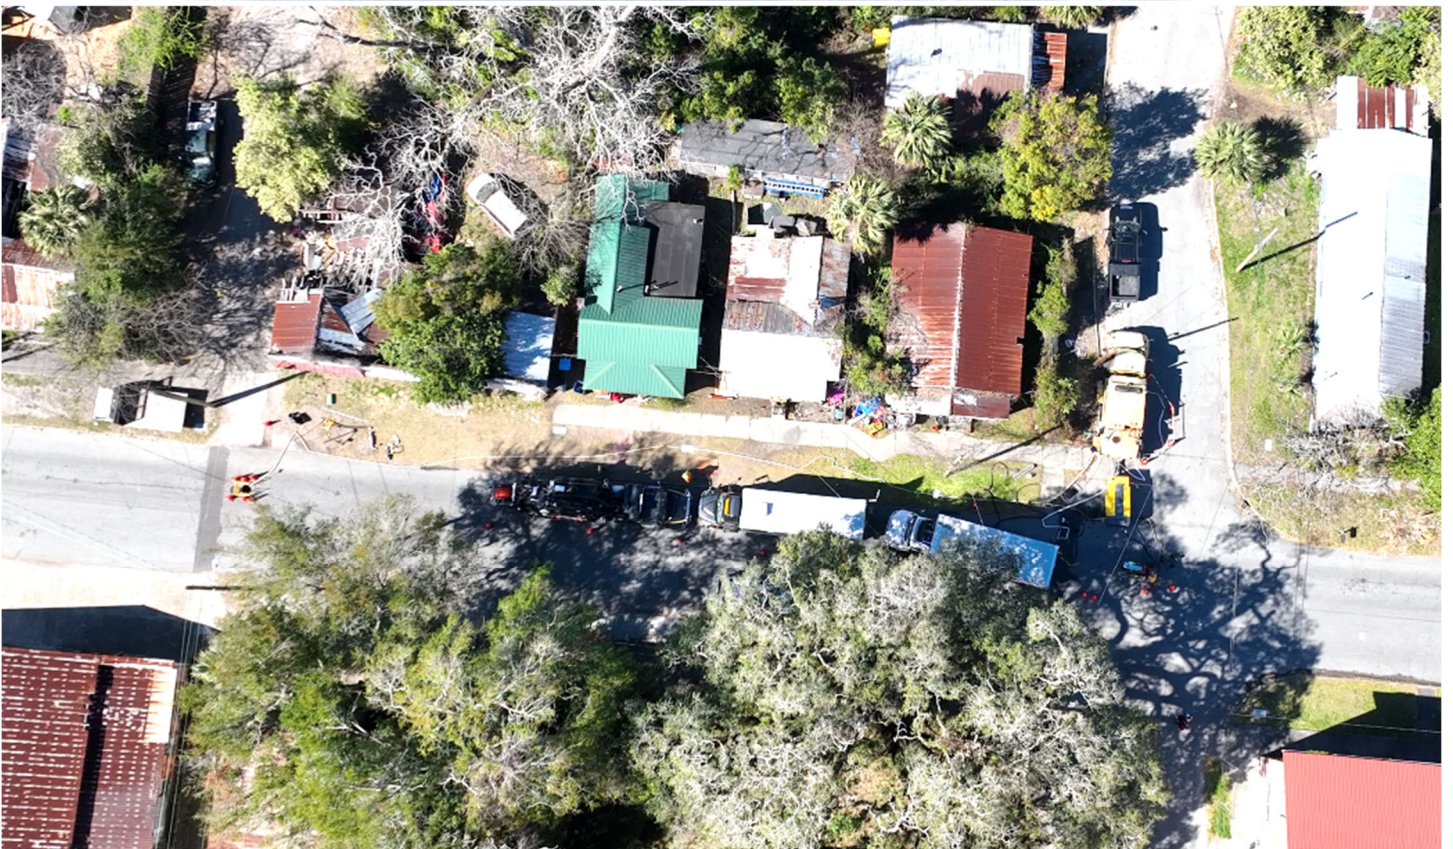
2. Drone overview of the 10-inch CIPP liner installation on I Street between Norwich Street Alleyway and Wolfe Street. The sewer line installation was approximately 183 LF.

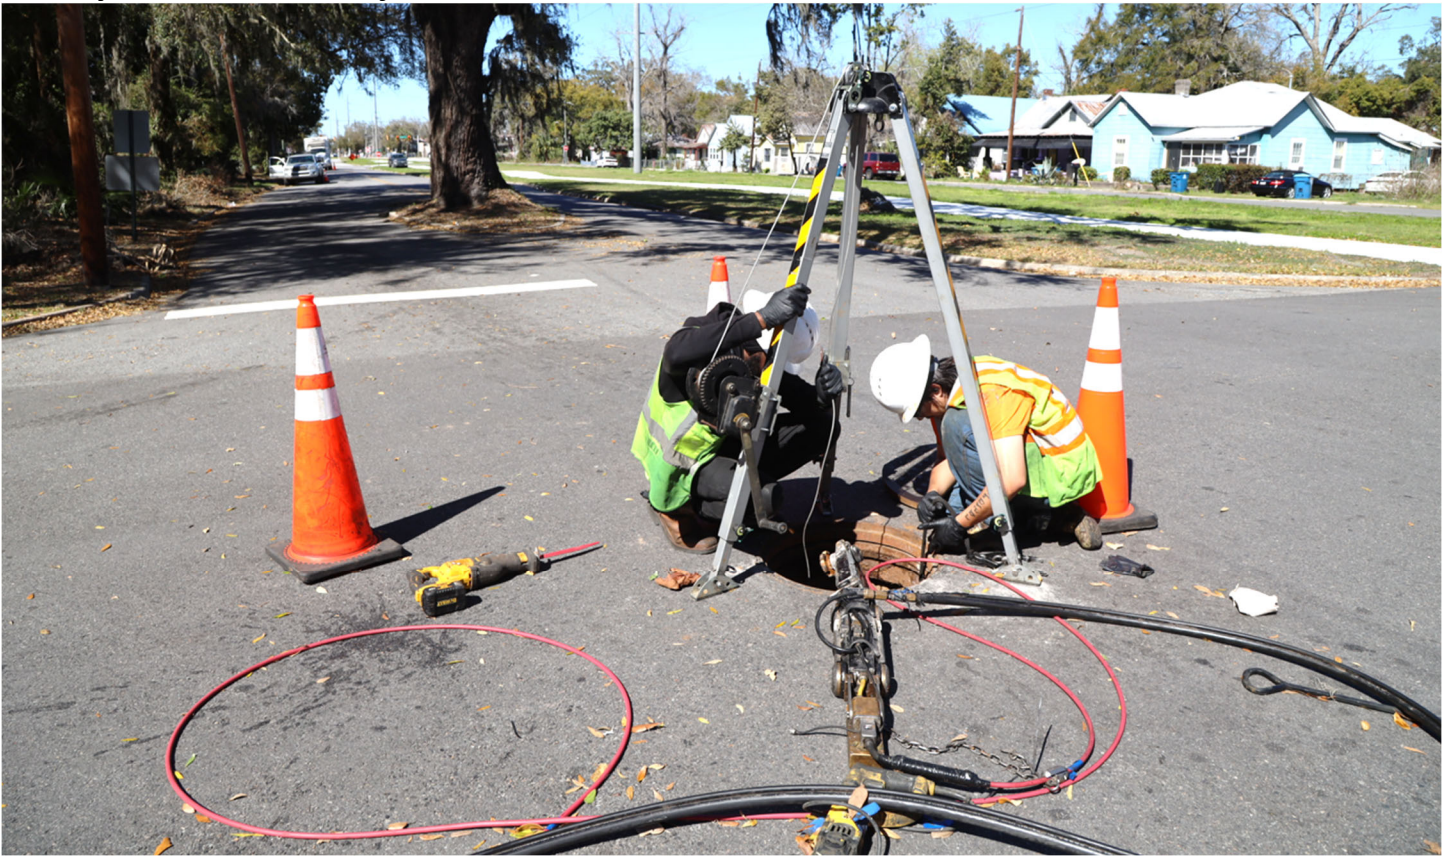
3. Bio-Nomic Operators prepare for PreCCTV and cleaning activities at manhole #400220100 next to 1409 Mansfield Street.
4. Kevin Eiler (Bio-Nomic CCTV Operator) performs PreCCTV cleaning using a robotic 4-inch blade cutter to remove tuberculation building within the 8-inch sewer pipe near 1304 MLK JR BLVD.

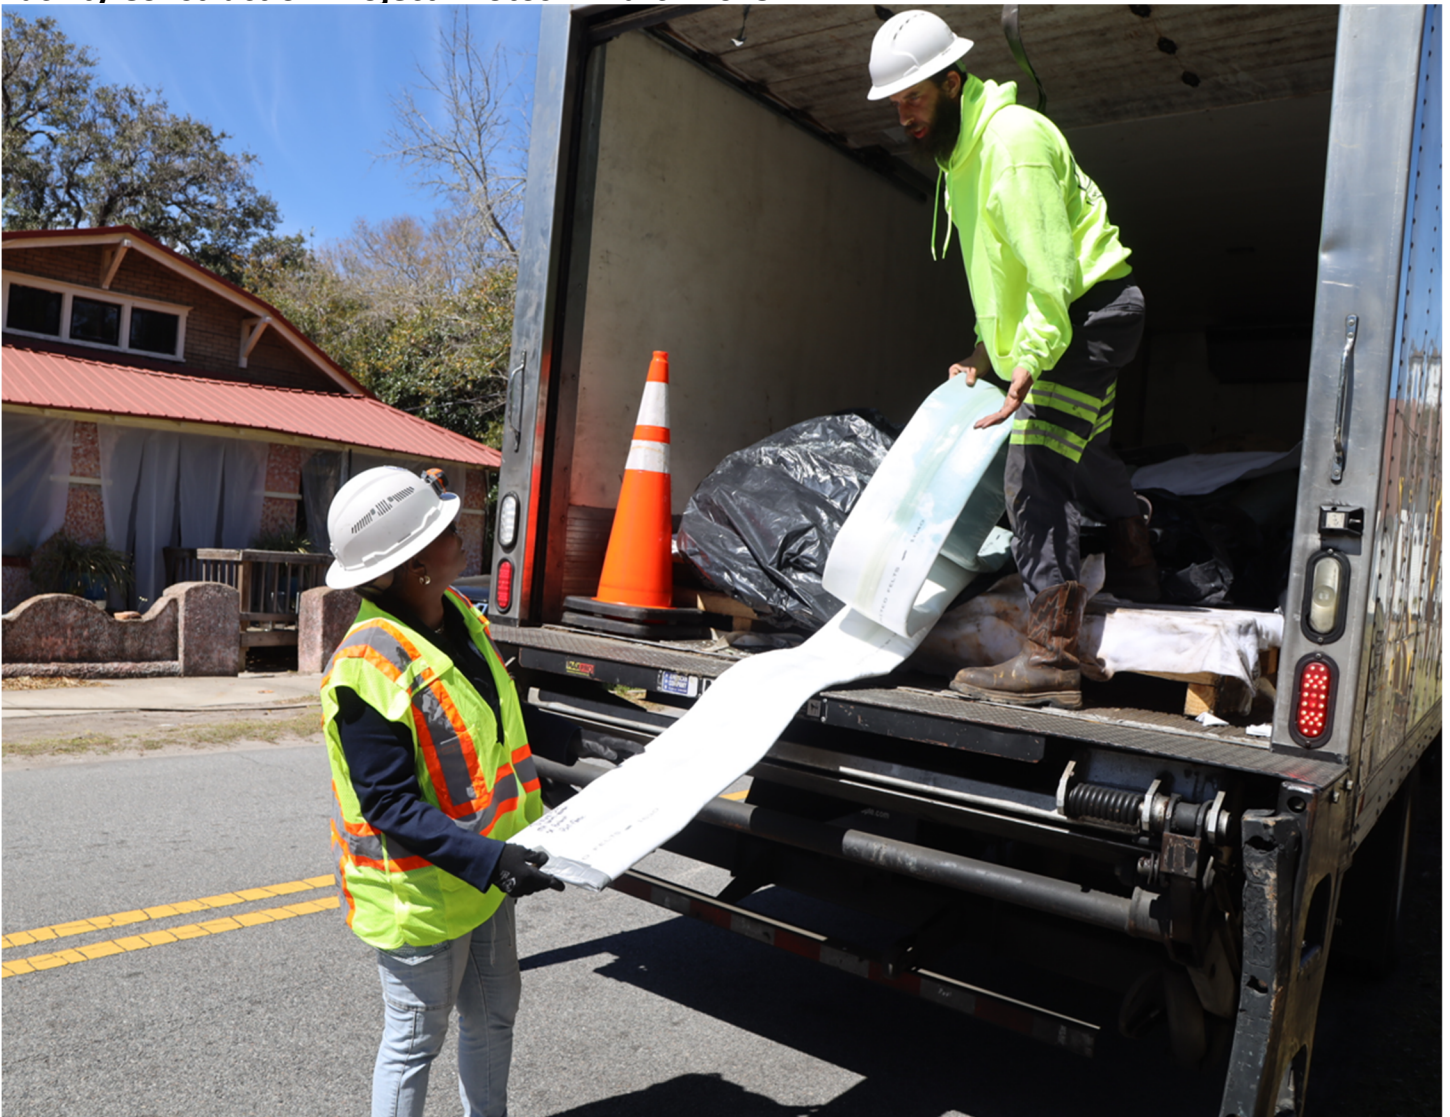
5. Leroy Hooey (Bio-Nomic Site Superintendent) showcases an 8-inch CIPP liner and explains the CIPP process to Maria DeJesus (JWSC Customer Service Representative) near 1406 Amherst Street.
